The role of handpump corrosion in the contamination and failure of rural water supplies

VINCENT CASEY, LAWRENCE BROWN,
JACOB D. CARPENTER, JACINTA NEKESA,
and BONNY ETTI

Keywords: handpump corrosion, iron, water quality, Uganda

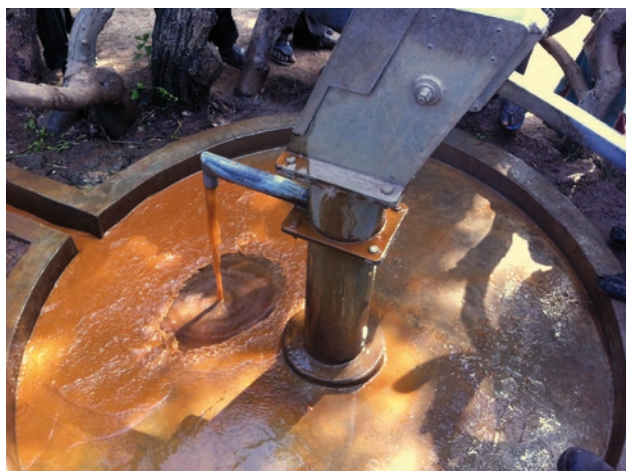
Figure 1 Example of turbid discharge, Aberan village, Amuria District, Uganda

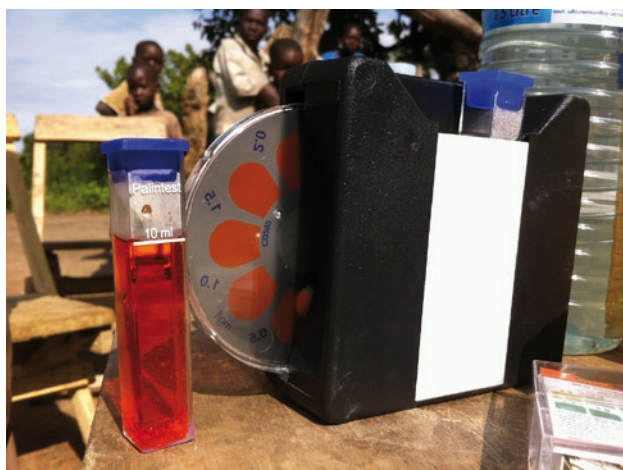
The iron-testing kit (Figure 2), manufactured by Palintest, uses a simple colour comparison method requiring the addition of a single reagent, in tablet form, to produce a colour change in the sample, the intensity of which is proportional to the

Figure 2 Palintest comparator test kit

concentration of iron. The colour of the test sample is then compared to a standard colour disc. For this study, the High Range (0 to 10 mg/l) test kit was used.

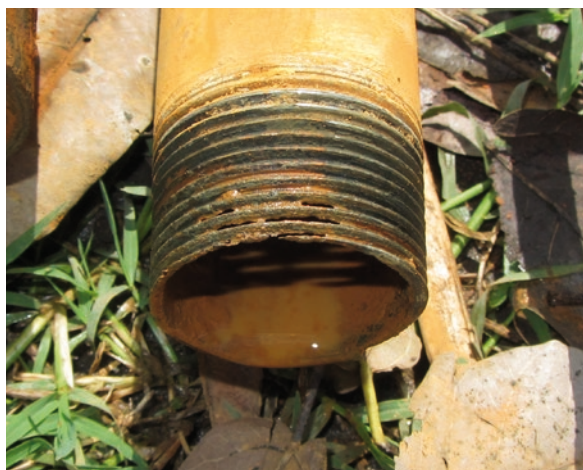
Figure 6 Threads on riser pipe at Odengelo, one year after installation

Following the tests, the riser pipes on some of the handpumps were withdrawn to allow inspection for signs of corrosion. Evidence of corrosion products was seen at all the sites and in particular at Odengelo village where the riser pipe was found to be leaking. The threads on several pipe joints at this handpump were severely damaged (Figure 6) and also indicated the use of sub-standard material. This borehole was only completed in October 2013 and the pump installed in December 2013, indicating how rapidly corrosion can affect a handpump in aggressive groundwater conditions. It is clear that this process would lead to more leakage and possibly to joint failure.

Where corrosion is identified as the origin of the iron, remedial action may comprise retrofitting corrosion-resistant materials to existing pump heads, or

replacing the pumps with corrosion-resistant alternatives (Afridev, Blue Pump, U3M), where these are appropriate. Each solution, however, comes with its own set of constraints that must be considered.

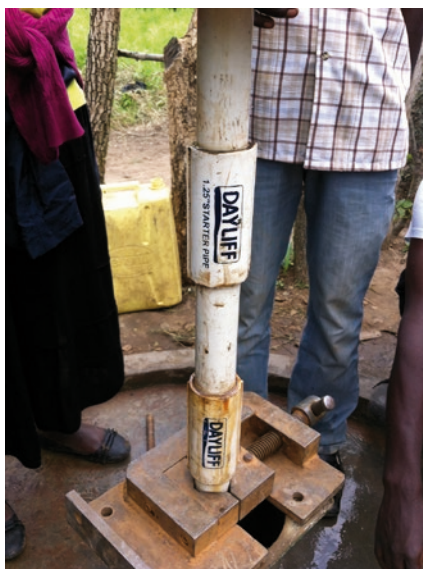
The third borehole at Angodingod (Figure 7) was a U2 fitted with 1¼" PVC riser pipe (supplied by Davies and Shirliff, Kampala) and GI pump rods. The Palintest results from two samples indicated iron concentrations less than 0.5 mg/l, confirmed by laboratory results of 0.06 mg/l. A pH of 6.2 was measured in the sample. Overall experience of this installation has been positive to date. The community has reported an acceptable yield and an absence of coloured water in the early morning, as was the case with pumps with galvanized iron riser pipes.

Figure 7 PVC riser pipe fitted to an India MkII pump at Angodingod

The retrofitting of 1¼" PVC pipes to U2 pumps has been trialled on a few pumps with positive results. However, low supplier stock levels of the pipe have inhibited trials on other pumps. There are also concerns with possible weaknesses associated with the reduced strength of threaded PVC joints. The promising performance of the Davis and Shirtliff pipe should be monitored and trials expanded to a greater sample of pumps at various installation depths. WaterAid is yet to test the maximum depth at which the pipe can operate without impaired performance. Further engagement with others that have researched the use of 1¼" PVC pipes will also be useful, as there is little published material on the topic.
