Sustainable management of water utility in Samoa through services improvement with Okinawa Water Bureaus

Abstract: *This study examines how Samoa improved the capacity of Samoa Water Authority (SWA) by implementing integrated cooperation with water utilities in Okinawa Prefecture, and hardware and software development to reduce the high non-revenue water (NRW) ratio and improve water supply quality and inadequate water pressure. Standard operation procedures were formulated to enhance the capacity of SWA. The cooperation method adopted continuous on-the-job training with a bottom-up approach. Consequently, the NRW ratio was reduced from 68 per cent to 36 per cent and water supply with proper pressure was achieved in the targeted area. The quality of the tap water, in which many coliform bacteria were detected before the cooperation, achieved 100 per cent compliance with standards. The cooperation evidenced that improving water services can help users' understanding of tariff payments, although the water tariff increased for most consumers due to a shift from fixed to metered tariff.*

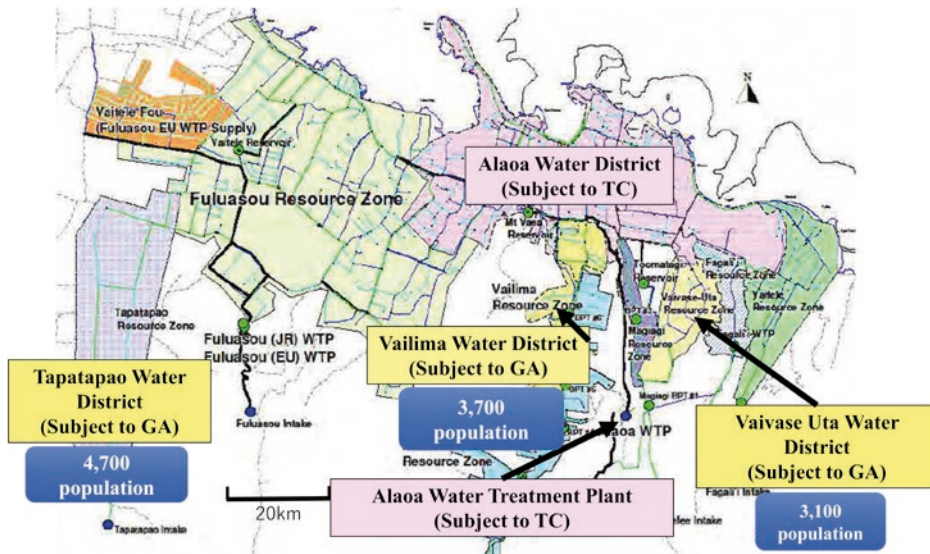
Figure 1 Location of assistance through different schemes in Apia City
 Note: GA: grant aid; TC: technical cooperation

With low quality of service, such as turbid tap water, it is difficult to increase revenue through water tariffs. Therefore, the SWA's integrated cooperation adopted a bottom-up approach. First, they improved the service; then, by delivering results to the customers, they built a relationship of trust with them, which increased the customers' willingness to pay. They shifted from a fixed tariff system to a metered system; and they improved the management of SWA along with the reduction of NRW. Capacity development alone was not sufficient to improve the water supply situation in Apia City; therefore, the water supply infrastructure was improved through a grant aid project. The Japan International Cooperation Agency (JICA) worked with local governments in Okinawa Prefecture to implement a package of cooperation that combines several schemes: short-term training courses, technical cooperation projects, and grant aid projects, which included hardware and software support. Figure 1 shows the location supported by the grant aid project and technical cooperation in Apia City.
