# LOW-COST CIVIL WORKS FOR MICRO-HYDRO SCHEMES

## MICRO-HYDRO SCHEMES IN CAJAMARCA PERU

Civil works can suffer from cracking and significant scour damage. This document looks at some of the approaches that were taken to combat these problems in hydro schemes in the Cajamarca region of Peru.

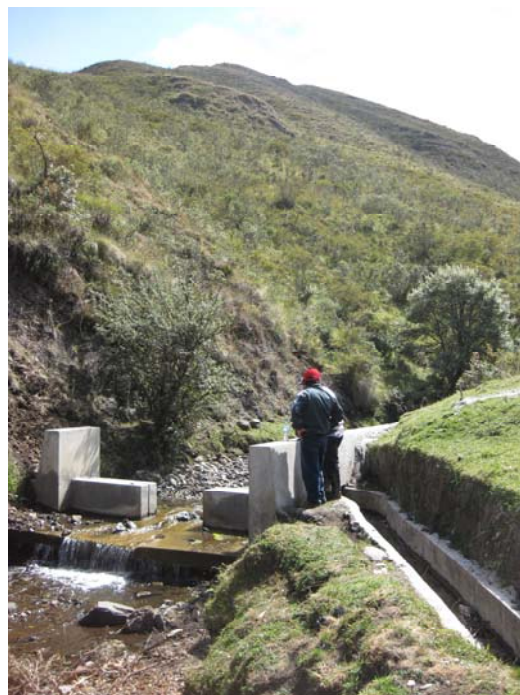
Figure 1: The intake structure with stoplogs removed at El Regalado. The structure is made with reinforced concrete and erosion on the channel side slopes is visible. Photo: Sakthy Selvakurmaran.

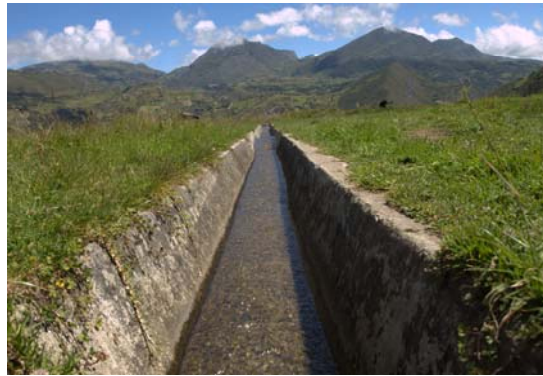
Figure 2: One of the concrete lined channels. These are built very cheaply with no shuttering, minimal expansion joints and thickness of just 50 – 75 mm. Photo: Sakthy Selvakurmaran.

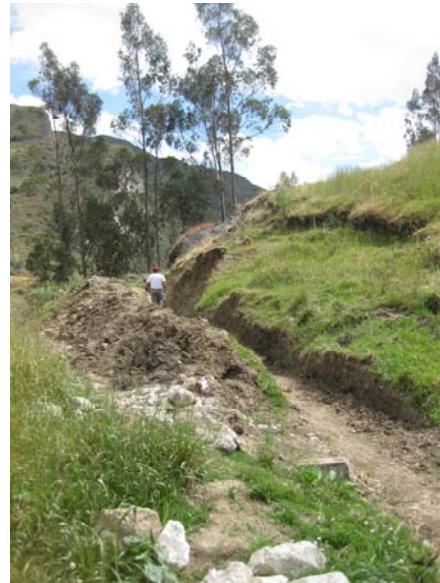
Figure 4: The diversion channel at Yanacancha after a slope collapse – faults due to soil creep are clearly visible.  
Photo: Sakthy Selvakurmaran.

The geological characteristics of the land vary between schemes across the Cajamarca region, but as an example to illustrate a typical scenario where problems occur, the Yanacancha Micro-Hydro system can be used. In terms of morphology, the area is located in the middle-lower part of the river basin that drains the Llaucano River. The valley presents mountainsides of moderate slope with good vegetation cover consisting primarily of grasses and some pine, eucalyptus and queñuales (a genus of shrubs and small trees endemic to the Andes). The land where the micro-hydro structures are located is predominantly dedicated to livestock grazing and to related agricultural production. Towards the downstream end of the system where the settling tank and the turbine house is located, the terrain becomes more rugged with steeper slopes. The zone around the intake structure is composed primarily of a sedimentary rock formation composed of limestone, marl and fine clays. These conditions make for fairly unstable soils that slide easily – particularly during the rainy season from November to April, but also when under the influence of excessive moisture from infiltration and uncontrolled flood irrigation applied to the grasslands.

In several schemes, the channels run through land which is used for other purposes (such as agricultural farming) and the land is irrigated, adding water to the soils and aggravating the instability. In negotiating use of land to construct such schemes, it is also important to consider such effects, and how use of the land by owners may impact on the scheme during operational use.

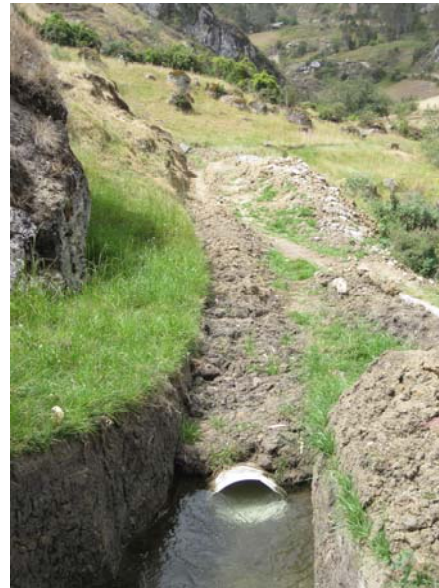
Figure 5: Buried pipe can be used to replace channels that have been destroyed by slope collapse but this is expensive. Photo: Sakthy Selvakurmaran.

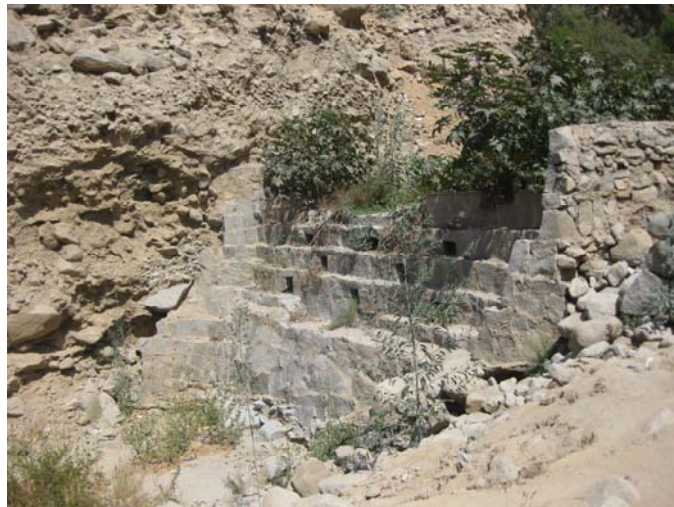
Figure 7: An example of a Peruvian stone wall constructed in the last decade to dissipate energy from landslides moving down the Rimac River. Intake structures can be constructed in a similar way. Photo: Sakthy Selvakurmaran.

Peruvian culture has a history of stonemasonry structures that dates back thousands of years – structures built by Incan civilisations that have withstood earthquakes and landslides remain standing to this day. Masonry walls have been used on a small scale in some of the micro-hydro systems to repair damaged zones. Where sufficient stones are available, a masonry solution could be used to construct the intake structure itself (such as a mass gravity side wall structure) and would help stabilise the slopes on either side.
