# FLOOD RESISTANT HOUSING

## LOW-COST DISASTER-RESISTANT HOUSING IN BANGLADESH

# technical brief

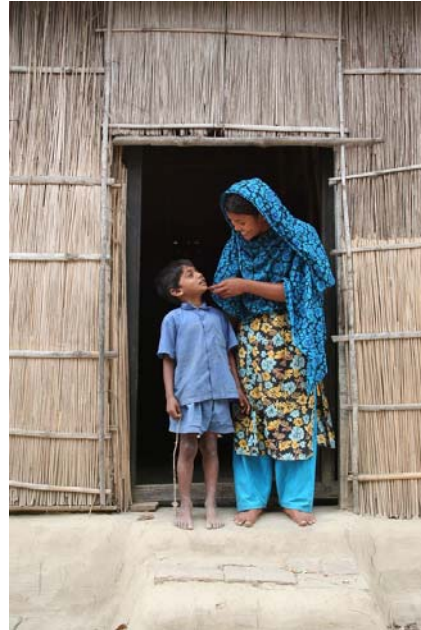
The house is built on a raised plinth made from sand, clay and cement (meaning it is less likely to be washed away in floods), and made using concrete pillars and treated bamboo poles. Strong and high enough to last through repeated floods, unlike the traditional earthen floors that simply wash away.

Figure 1: Hosne Ara (14 yrs) and Faruq Hussein (10 yrs) live with their parents in Wazuddin Fakirer Dangi, The house is built on a raised plinth made from sand, clay and cement. Photo: Practical Action Bangladesh.

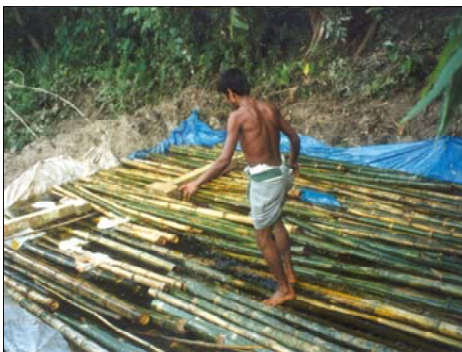
Figure 4: Curing bamboo trees for building flood resistant houses Faridpur, Bangladesh. Photo: Practical Action Bangladesh.

Bamboo poles are treated to make them more resilient to flooding so that they last longer.

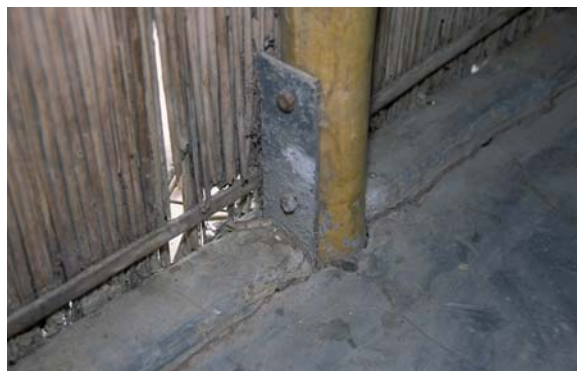
Reinforced concrete posts with footings were introduced to strengthen the structure. Short reinforced concrete stumps for the treated bamboo posts make the structure more resilient to the water.

Figure 5: detail of the footing. Photo: Practical Action Bangladesh.

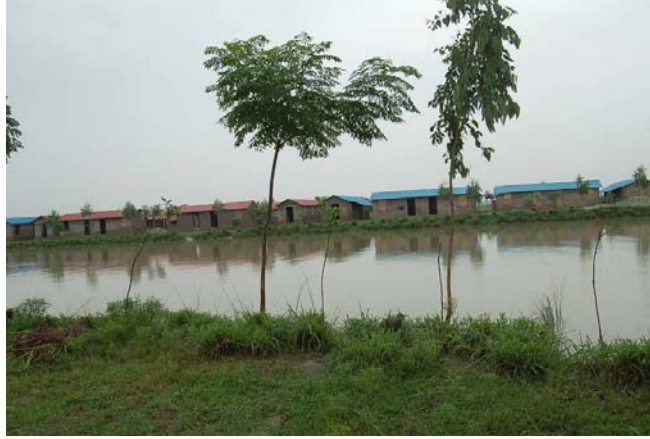
Figure 6 : A completed cluster village with pond for community fish culture. Photo: Practical Action Bangladesh.

Another integrated approach taken up by Practical Action was the resettlement of dam dwellers through the development of cluster villages where the whole village was built on raised land. 500 decimal (1 decimal is equal to 1/100 of an acre or approximately 40.46 m<sup>2</sup>) of land was acquired that was large enough to contain a small village, of up to about 100 houses and the height of earth embankment was determined by considering the flooding records for the previous 40 years i.e. ground level of cluster village should be 3 feet or 900 mm above the highest flood level.

The cluster village is made in a collaborative way; people excavate soil and sand from one area to build an earth platform. This is done in the dry season December to April. The hole where the soil/sand is excavated from creates a reservoir which is used by the community for various livelihood initiatives such as fish farming, duck rearing, floating gardens etc.

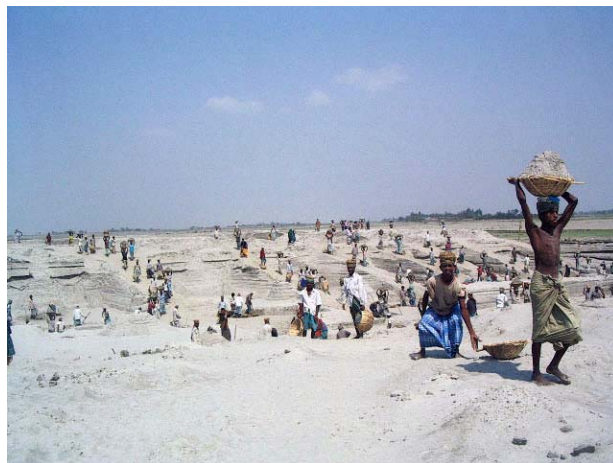
Figure 8: The whole community work together to make a large raised platform for the cluster village. Photo: Practical Action Bangladesh.

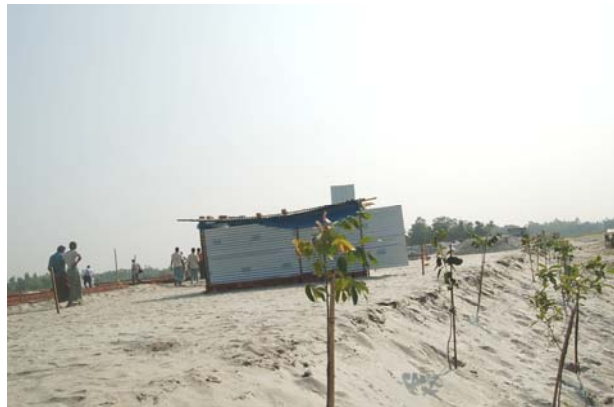
Figure 9: The newly finished earth raising is planted with young trees to stabilise the sandy soil. Photo: Practical Action Bangladesh.

The banks are stabilised by planting fruit trees and Napier grass (which can also be used as goat/sheep fodder).
